**SPCC Inspection Photograph Log**

**Jackson and Son Oil**

**84721 Happel Lane, Seaside, OR 97138**

**Inspection and Photograph Date: September 21, 2021**

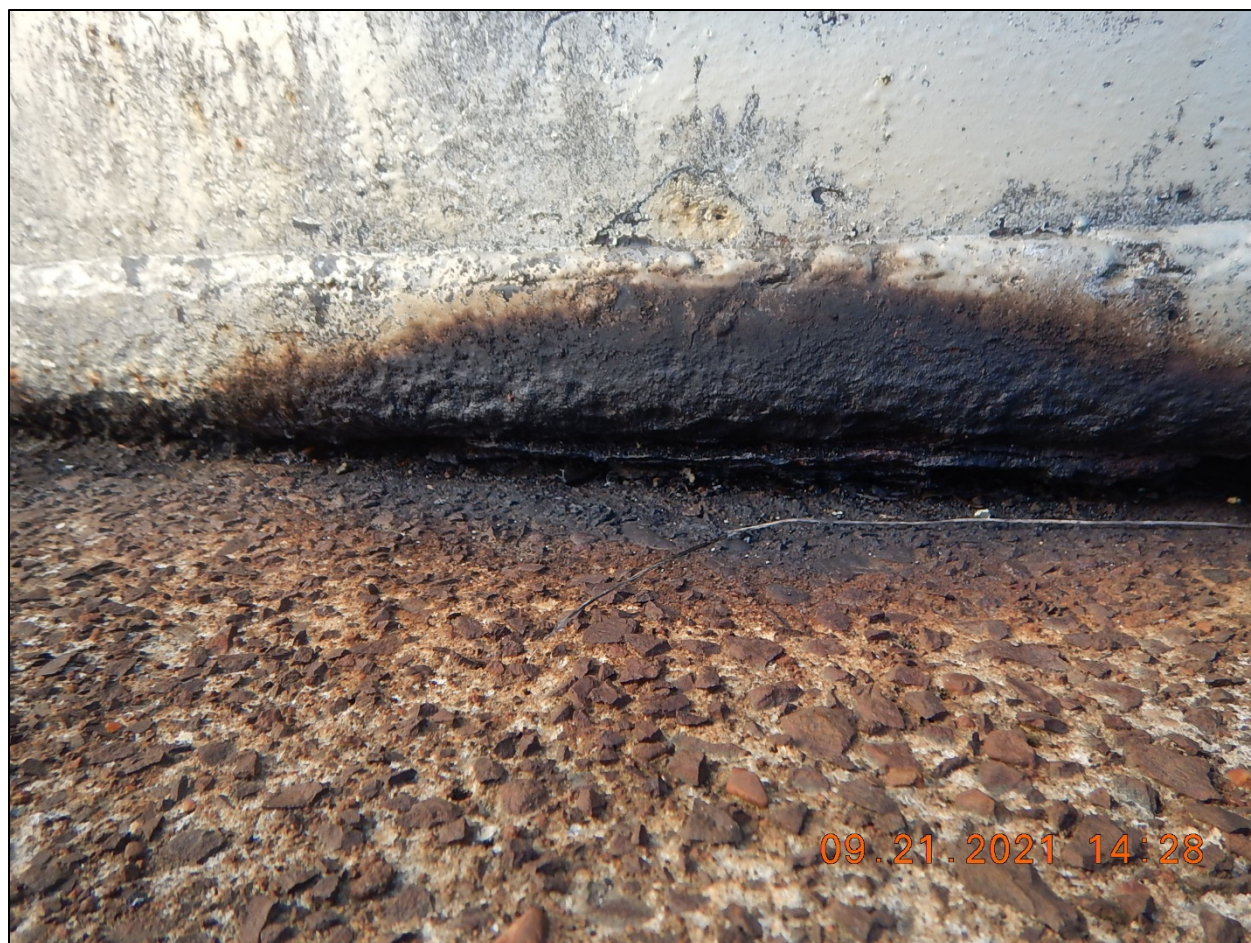
**Photograph 19.** Close-up view of an active oil leak and oil staining along the base of the second from the rightmost tank shown in Photograph 16. Note that these tanks had never received any formal integrity testing since being placed into service.

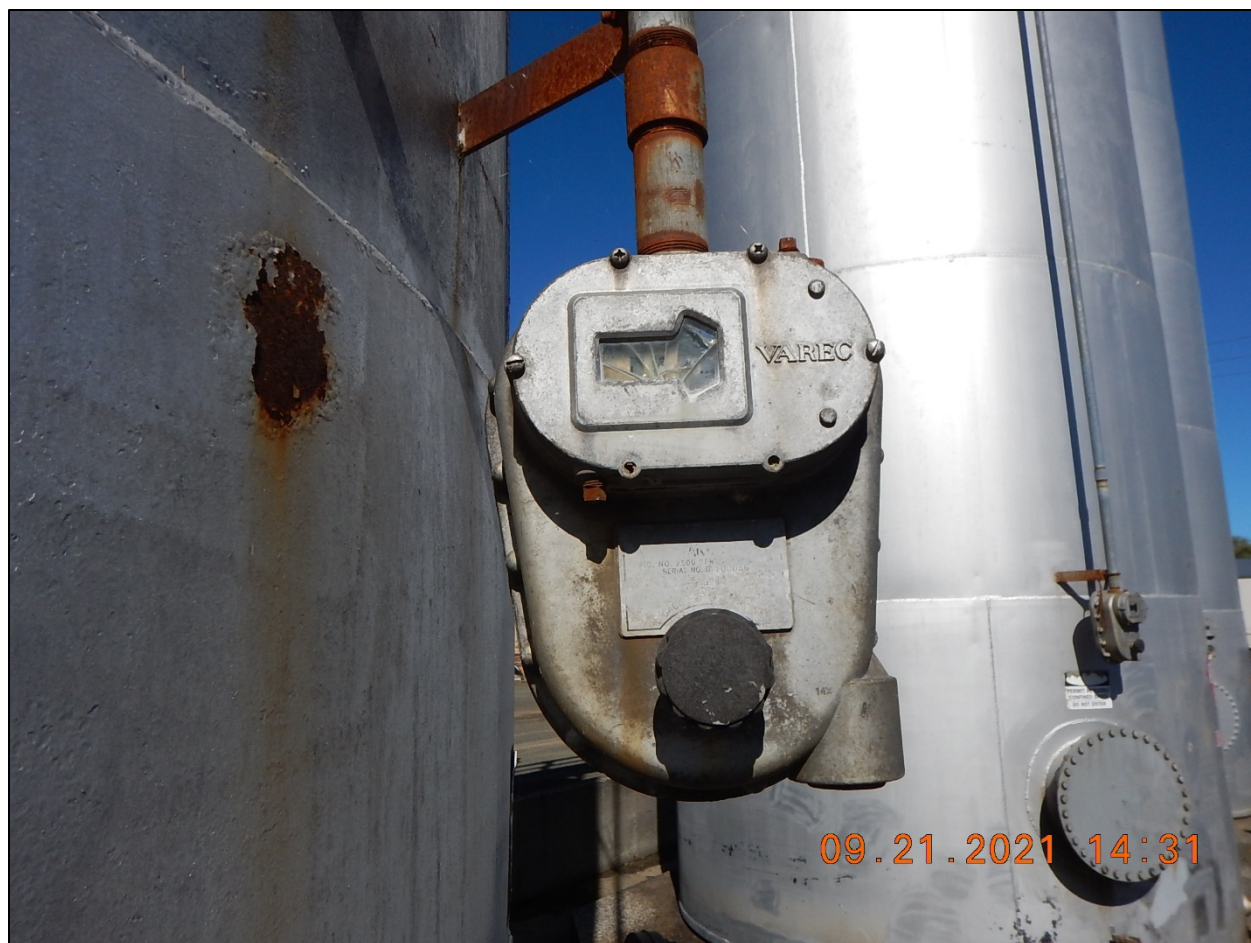
**Photograph 20.** View of a broken Varec tank gauge on the second from the rightmost tank shown in Photograph 16.

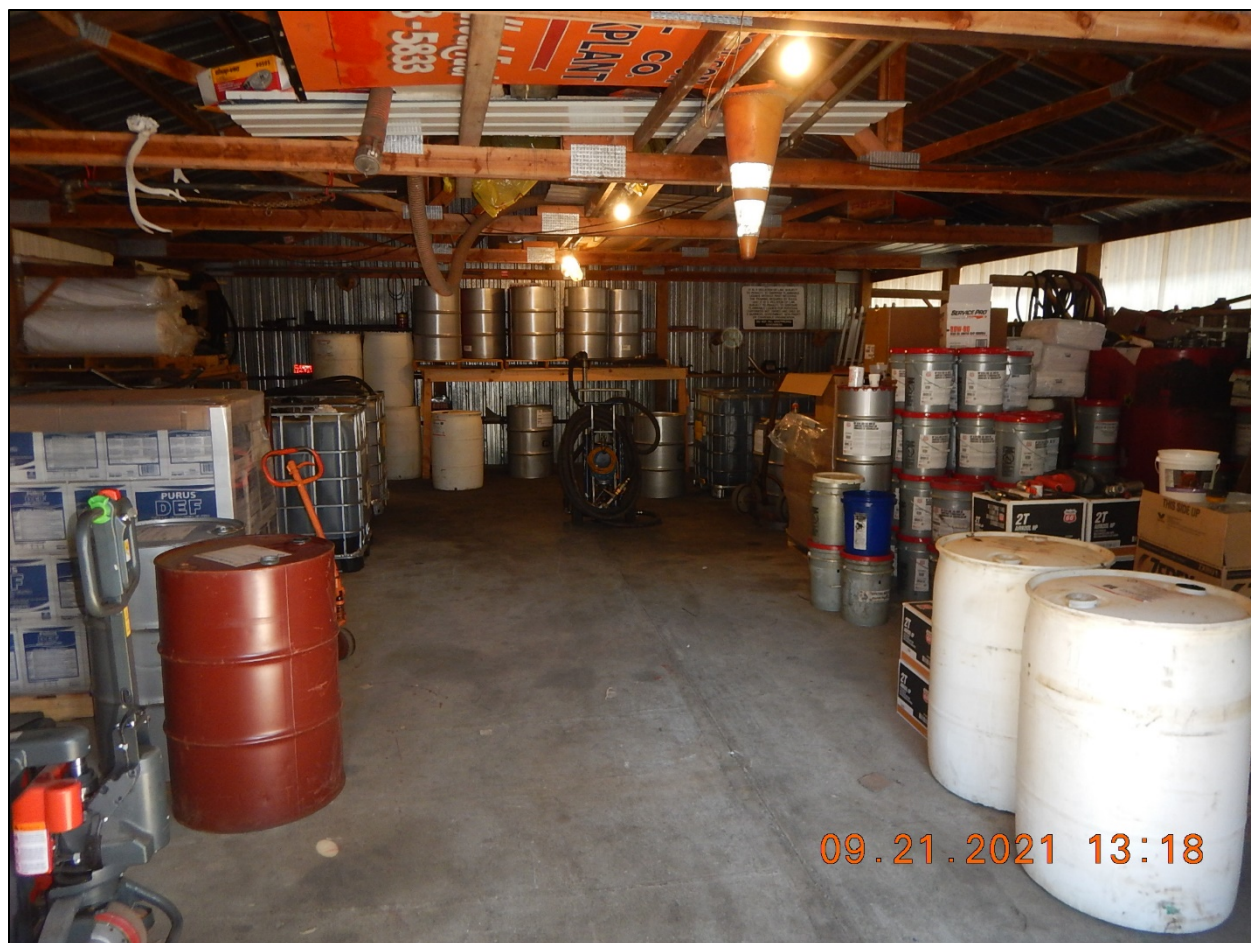
**Photograph 21.** View inside the facility's drum and tote storage warehouse. The warehouse contained approximately 14 55-gallon drums and 6 larger totes.

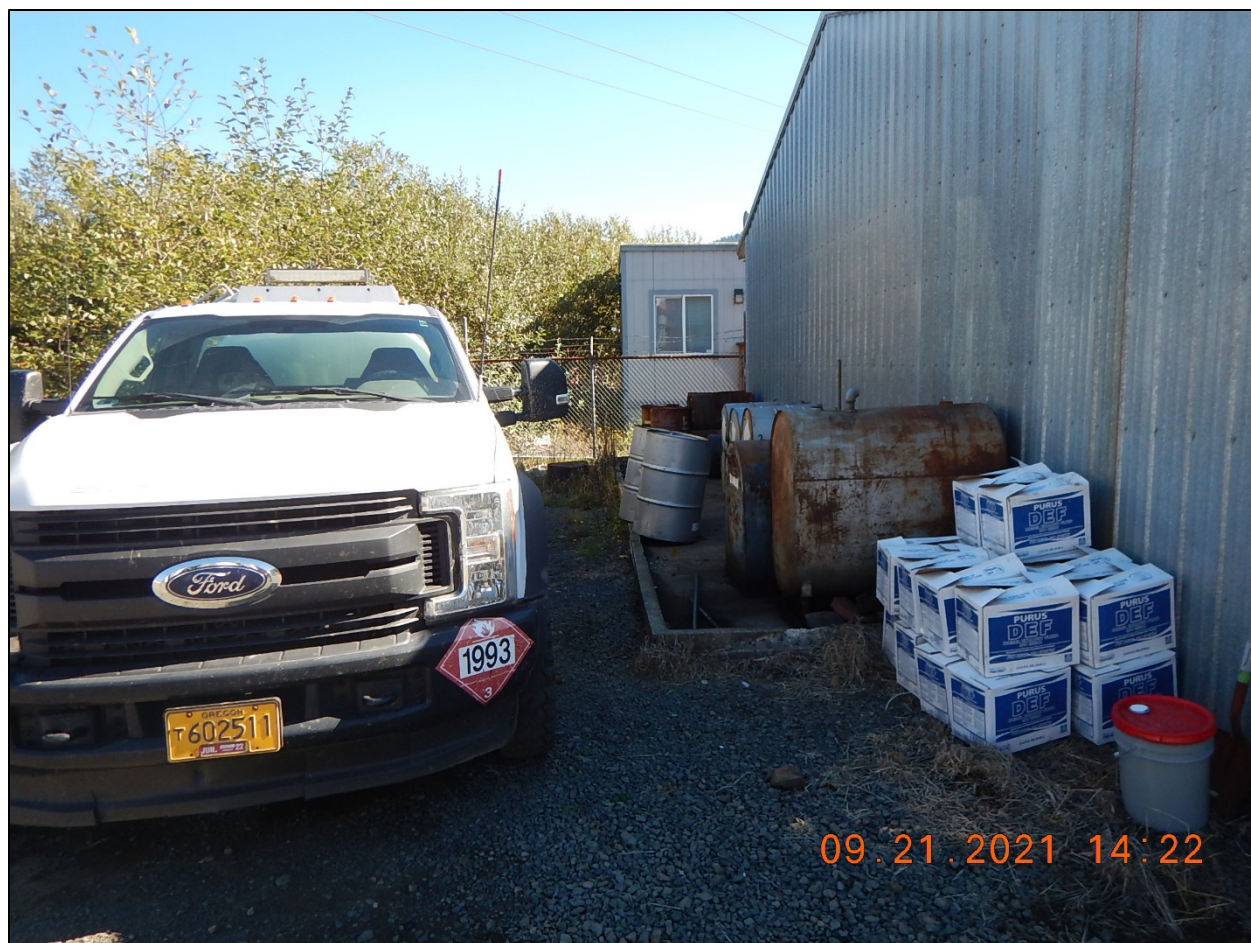
**Photograph 22.** View, facing northeast, of an additional drum storage area located behind the facility's drum and tote storage warehouse shown in Photograph 21.
